2019-2020 Florida Job Growth Grant Fund Public Infrastructure Grant Proposal

Name of Governmental Entity: Greater Orlando Aviation Authority

**ORLANDO
EXECUTIVE
AIRPORT (ORL)**

DISTRICT 5
REGIONAL RELIEVER
AIRPORT
JUNE 2015

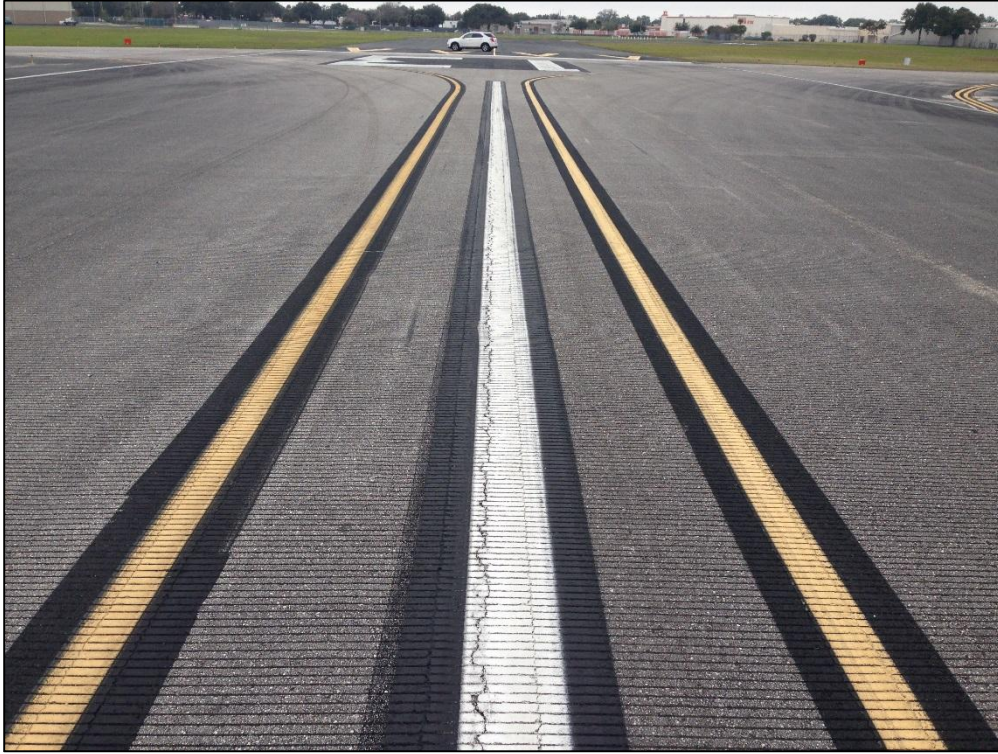
Runway 13-31, Section 6205, Sample Unit 195 – Low Severity (48) Longitudinal and Transverse Cracking, Low Severity (57) Weathering

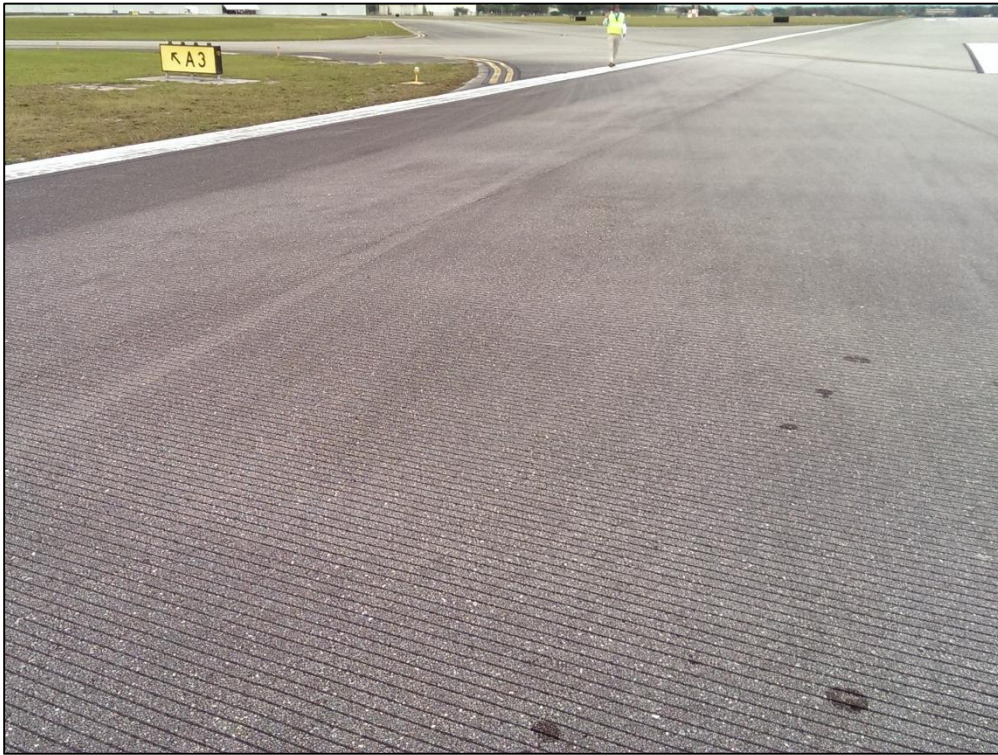
Runway 7-25, Section 6110, Sample Unit 176 – Low Severity (48) Longitudinal and Transverse Cracking, Low Severity (57) Weathering

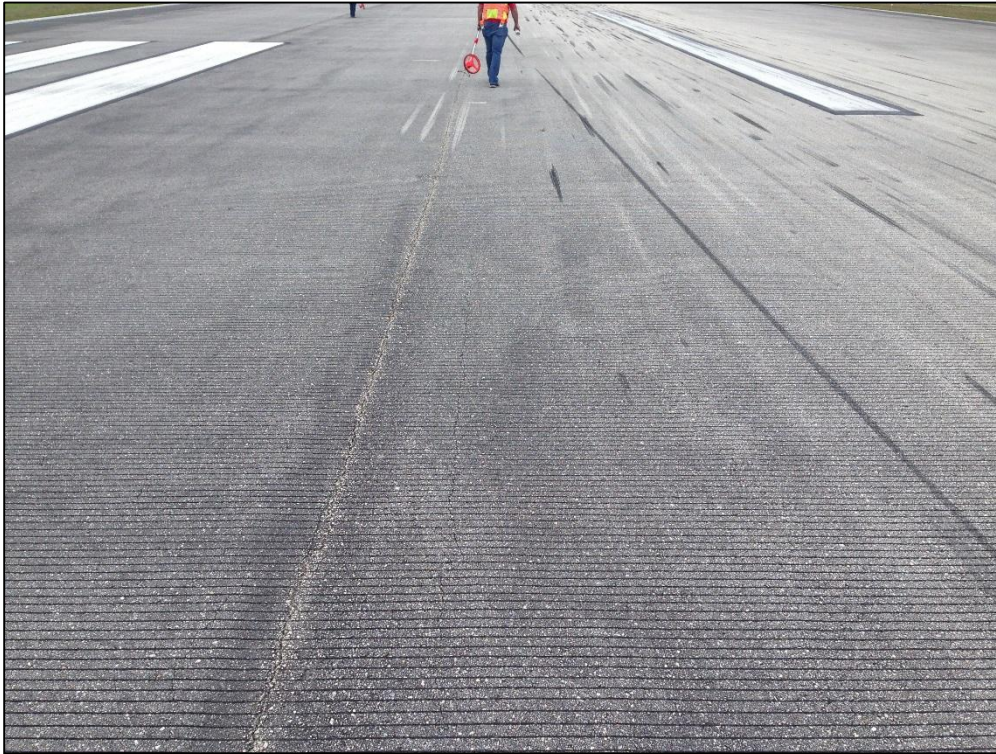
Runway 7-25, Section 6105, Sample Unit 409 – Low Severity (48) Longitudinal and Transverse Cracking, Low Severity (56) Swelling, Low Severity (57) Weathering

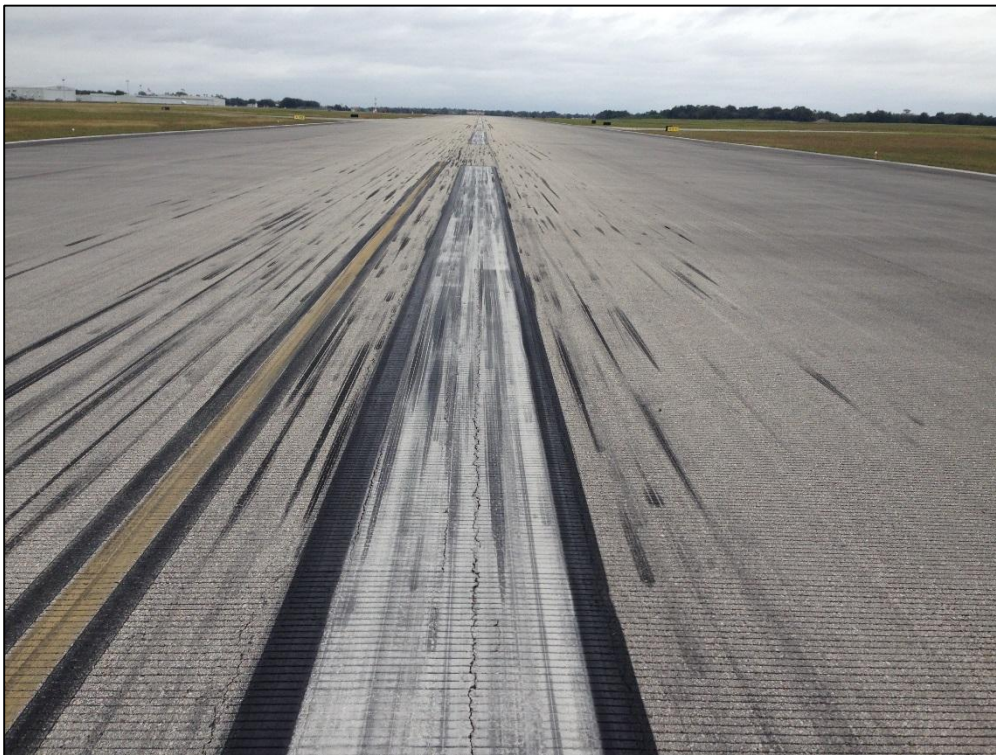
Runway 7-25, Section 6105, Sample Unit 342 – Low Severity (48) Longitudinal and Transverse Cracking, Low Severity (57) Weathering

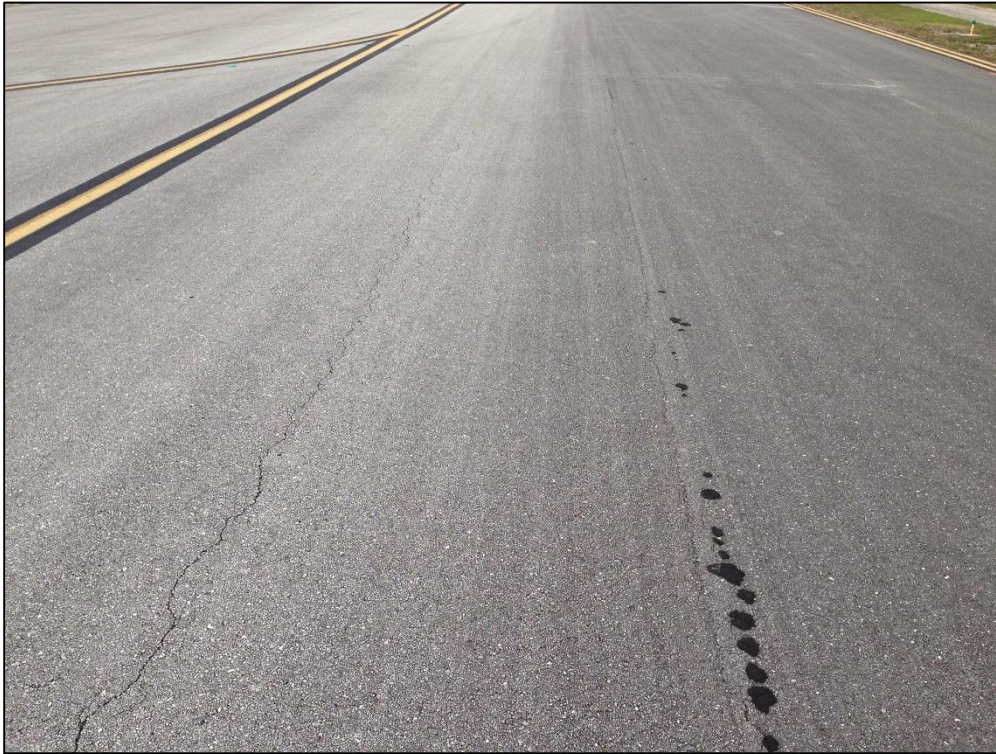
Taxiway Alpha, Section 125, Sample Unit 116 – (42) Bleeding, Low Severity (48) Longitudinal and Transverse Cracking, Low Severity (56) Swelling, Low Severity (57) Weathering

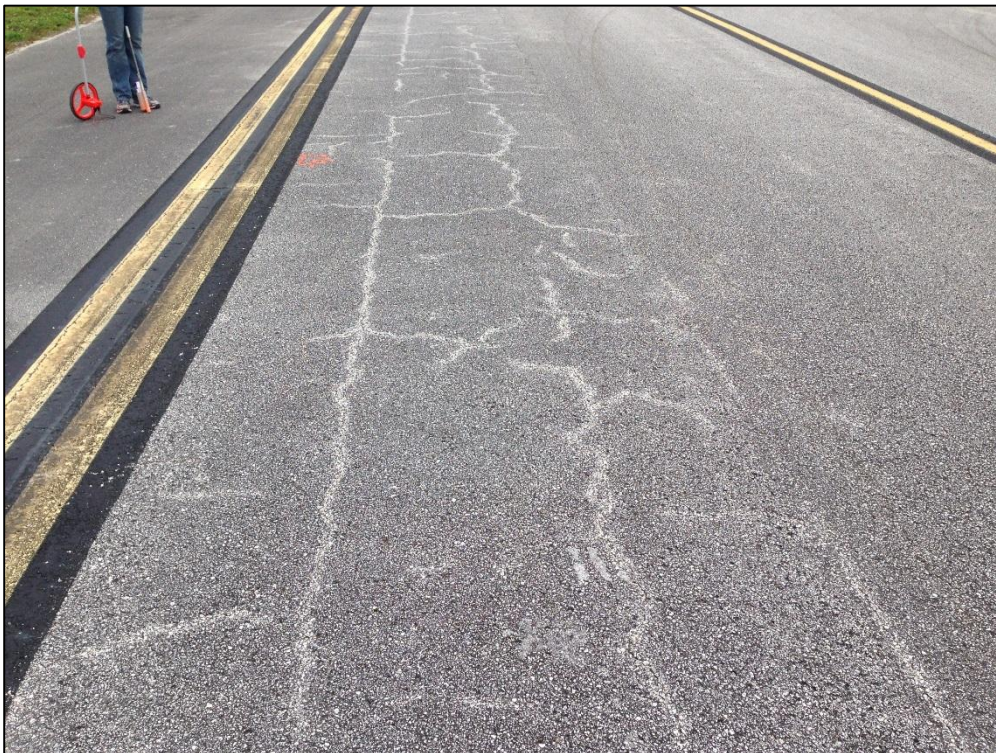
Taxiway Golf, Section 705, Sample Unit 701 – Low Severity (43) Block Cracking, Low Severity (52) Raveling, Low Severity (56) Swelling

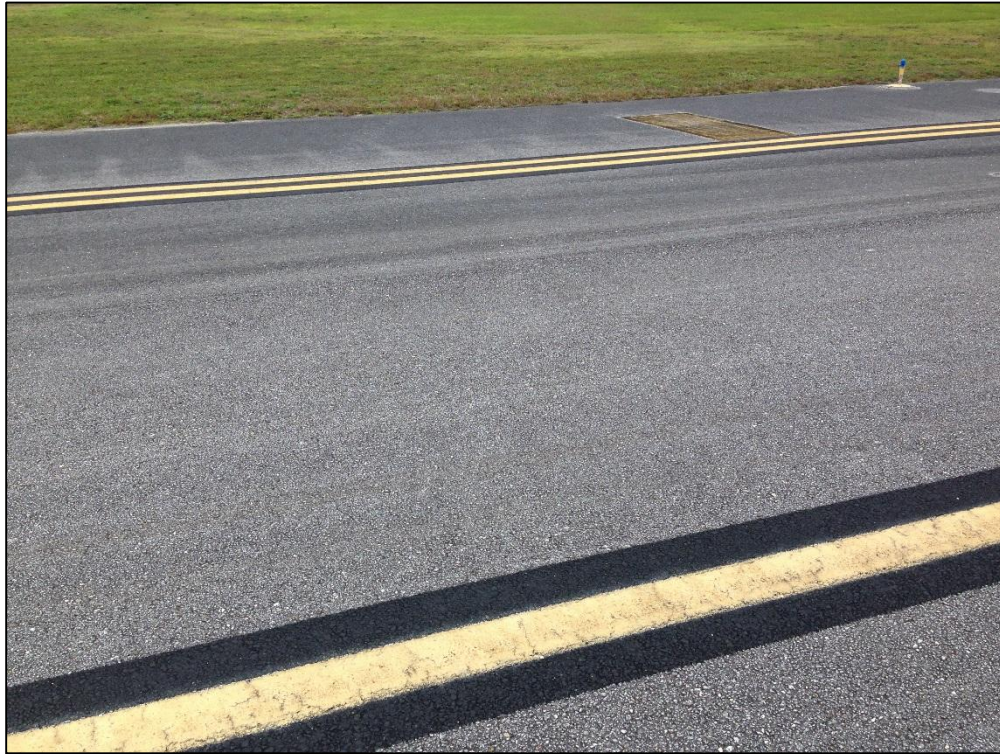
Taxiway E5, Section 560, Sample Unit 101 – Low Severity (52) Raveling, Low Severity (57) Weathering

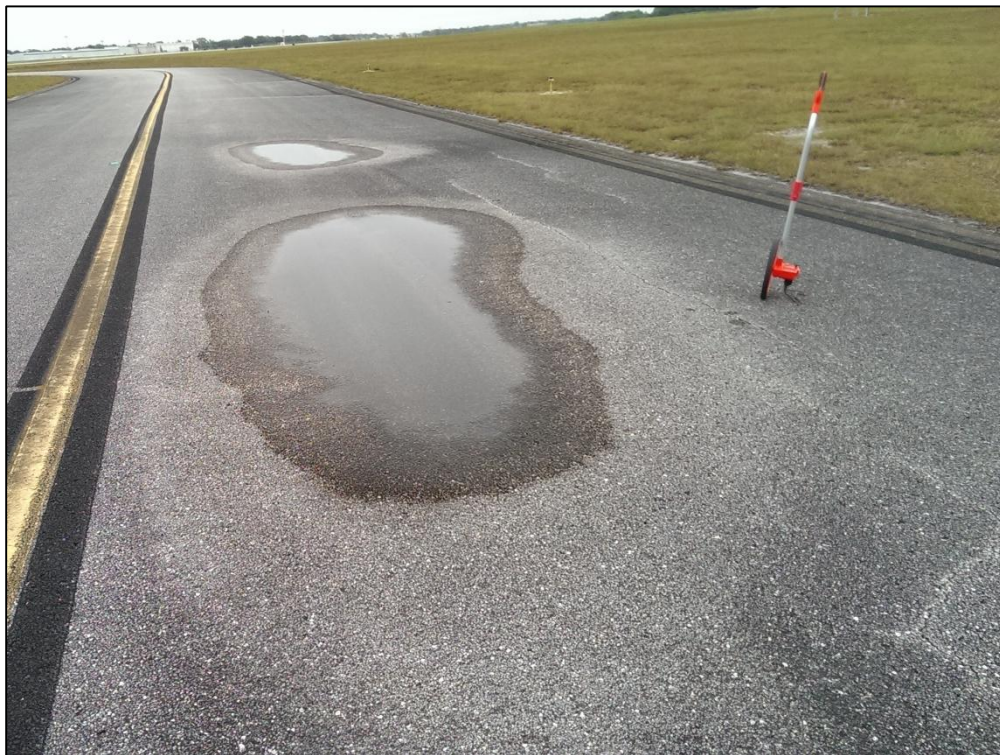
Taxiway E3, Section 420, Sample Unit 405 – Medium Severity (45) Depression, Low Severity (48) Longitudinal and Transverse Cracking, Low Severity (52) Raveling, Low Severity (57) Weathering

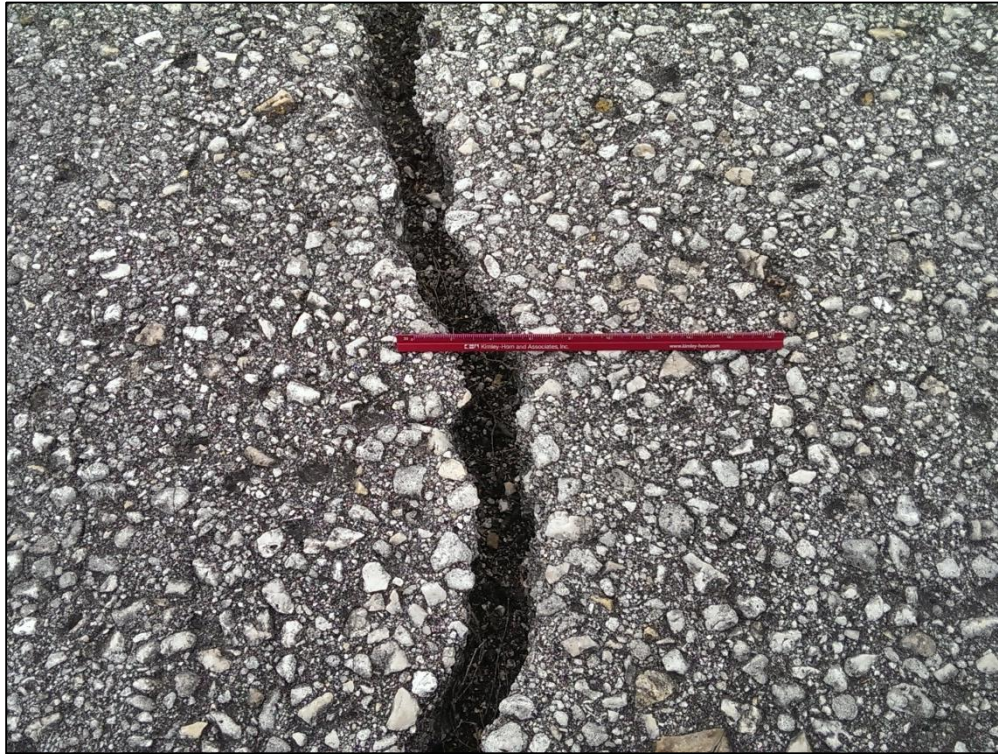
Taxiway E6, Section 805, Sample Unit 801 – High Severity (48) Longitudinal and Transverse Cracking, Low Severity (52) Raveling

- West Apron – Sections 4660 and 4665
 - Reconstruction attributed to load, climate, and age of pavement.
- West Apron – Sections 4610, 4640, and 4650
 - Mill and Overlay attributed to climate and age of pavement.
- Northeast Apron – Sections 4305 and 4312
 - Mill and Overlay attributed to climate and age of pavement.
- General Aviation Apron – Section 4205
 - Mill and Overlay attributed to climate and age of pavement.
- North Apron – Sections 4105, 4125, 4140, 4145, 4158, 4165, 4167, and 4168
 - Reconstruction attributed to load, climate, and age of pavement.
- North Apron – Section 4155
 - Mill and Overlay attributed to climate and age of pavement.
- Taxiway E4 – Sections 1070 and 1080
 - Mill and Overlay attributed to climate and age of pavement.
- Taxiway H – Section 806
 - Mill and Overlay attributed to climate and age of pavement.
- Taxiway E6 – Section 805

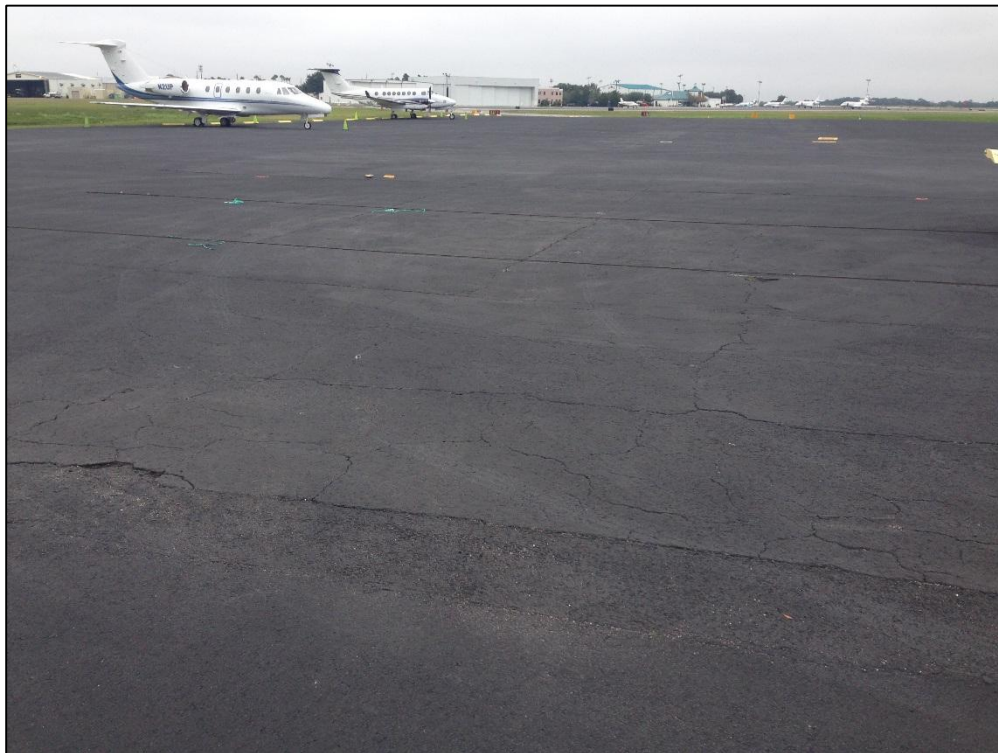
Apron West, Section 4660, Sample Unit 507 – Medium Severity (43) Block Cracking, Low Severity (52) Raveling

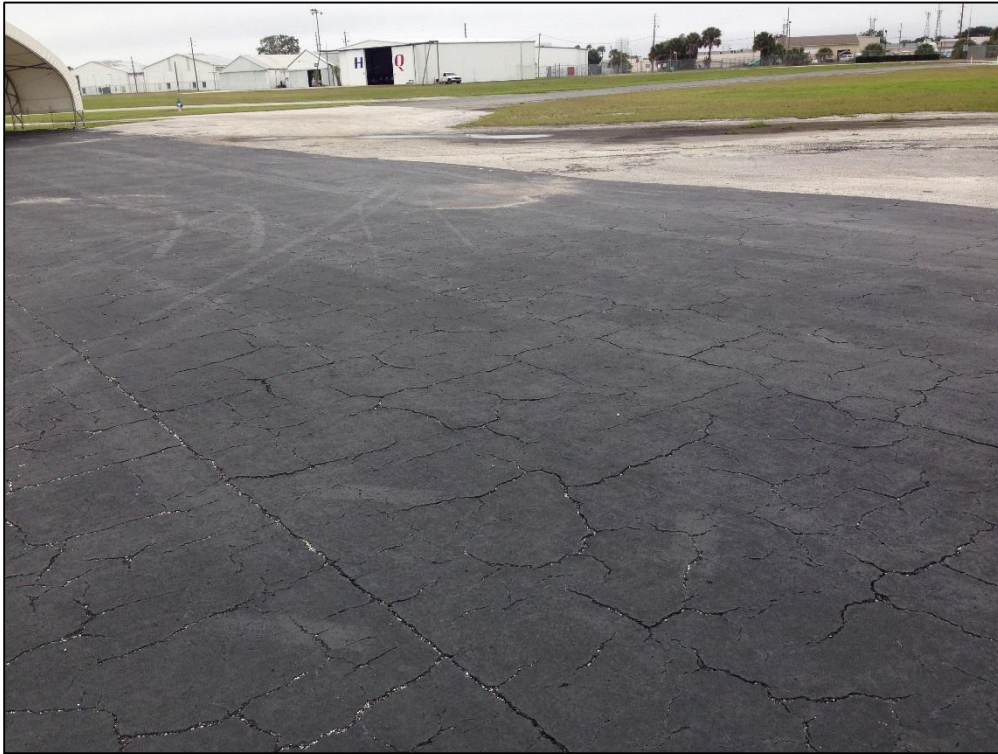
Apron North, Section 4158, Sample Unit 651 – High Severity (43) Block Cracking, Medium Severity (52) Raveling

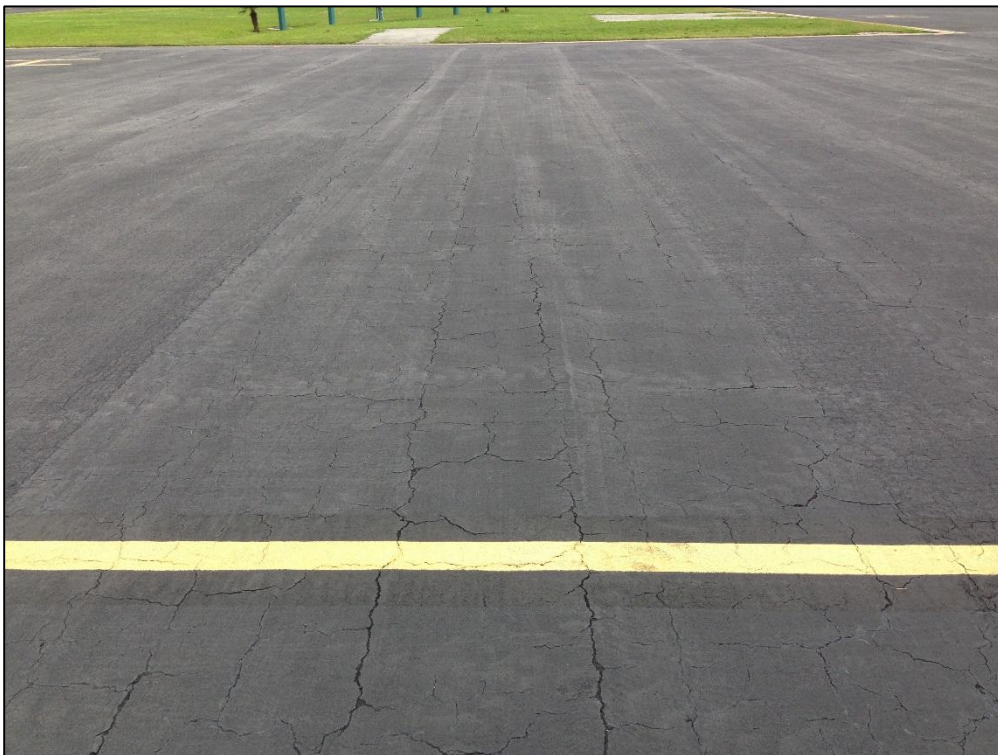
Apron North, Section 4145, Sample Unit 416 – Medium Severity (43) Block Cracking, Low Severity (57) Weathering, Medium Severity (57) Weathering

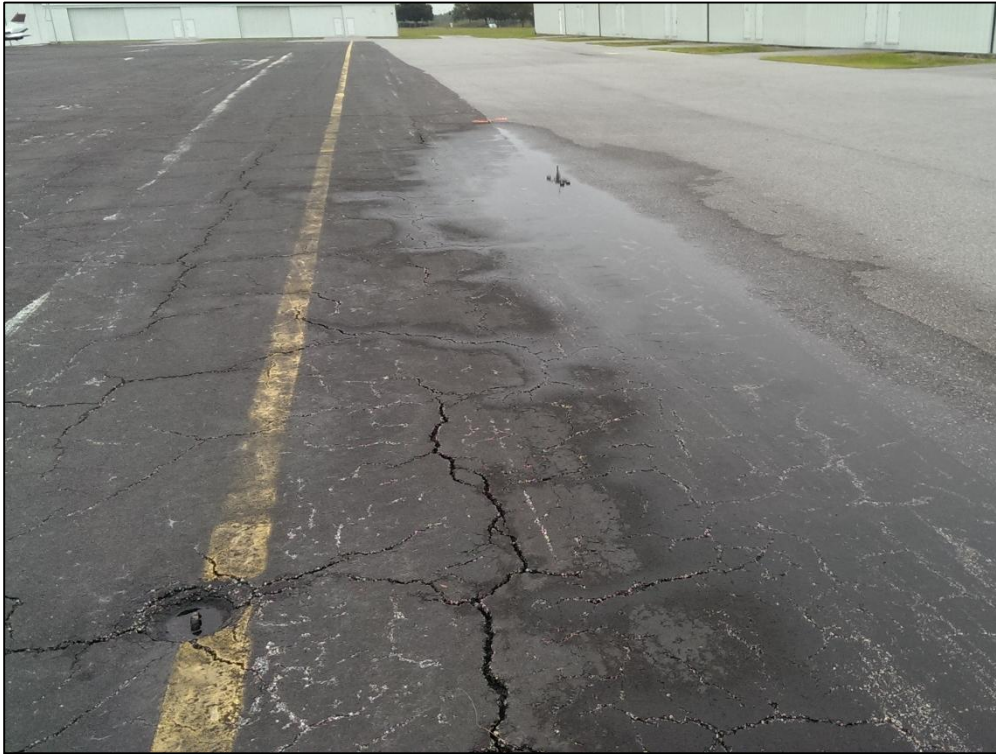
Apron Northeast, Section 4305, Sample Unit 350 – Low Severity (43) Block Cracking, Low Severity (53) Rutting, Low Severity (57) Weathering
